**SLOPE HAZARDS INVESTIGATION
510 KULI'OU'OU ROAD
TMK: 3-8-010:004**

Project No. SRSS00110

March 19, 2012

**Prepared by:
Horst G. Brandes, Ph.D., P.E.**

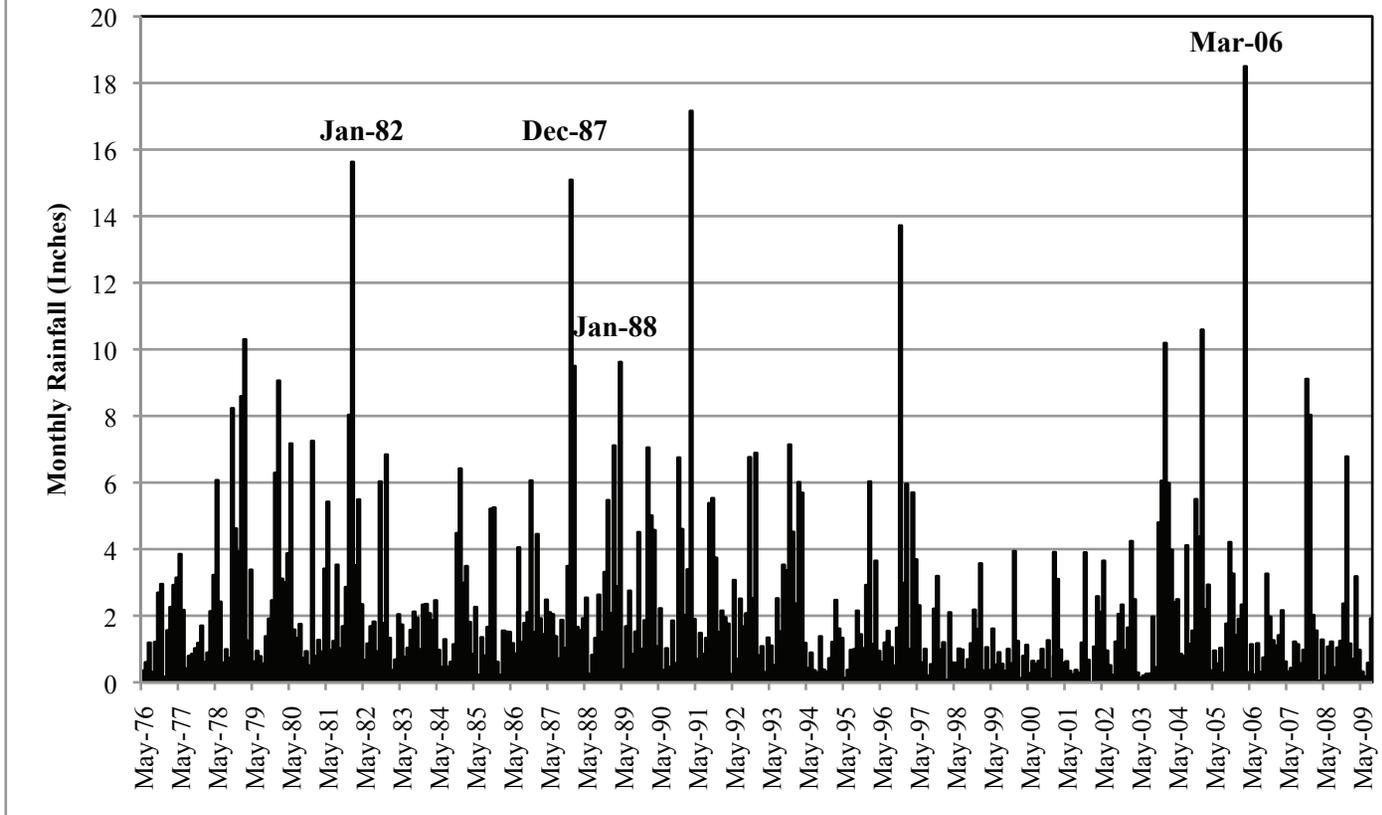
It is clear that there has been no reactivation of large-scale sliding since the New Year's Eve storm of 1987-1988. It should be noted that this is true despite several notable rain events since that time (Figure 2). In particular, heavy rainfall during March of 1991 and November of 1996 did not result in an acceleration of movement in any of the instruments. Also, the '40 days of rain' period of March-April 2006, while occurring after monitoring ceased, does not appear to have caused substantial additional sliding. Our field observations did not reveal structural distress in the ditches, culverts, and along Papahehi Road that can be attributed to that event. It has been reported that several of the ditches were filled with runoff during that period, indicating that the new and repaired storm structures were indeed effective in reducing potentially damaging infiltration of water into the body of the landslide.

Total Monthly Rainfall: 1976-2009
Paiko Drive Rain Gauge Sta. 723.4

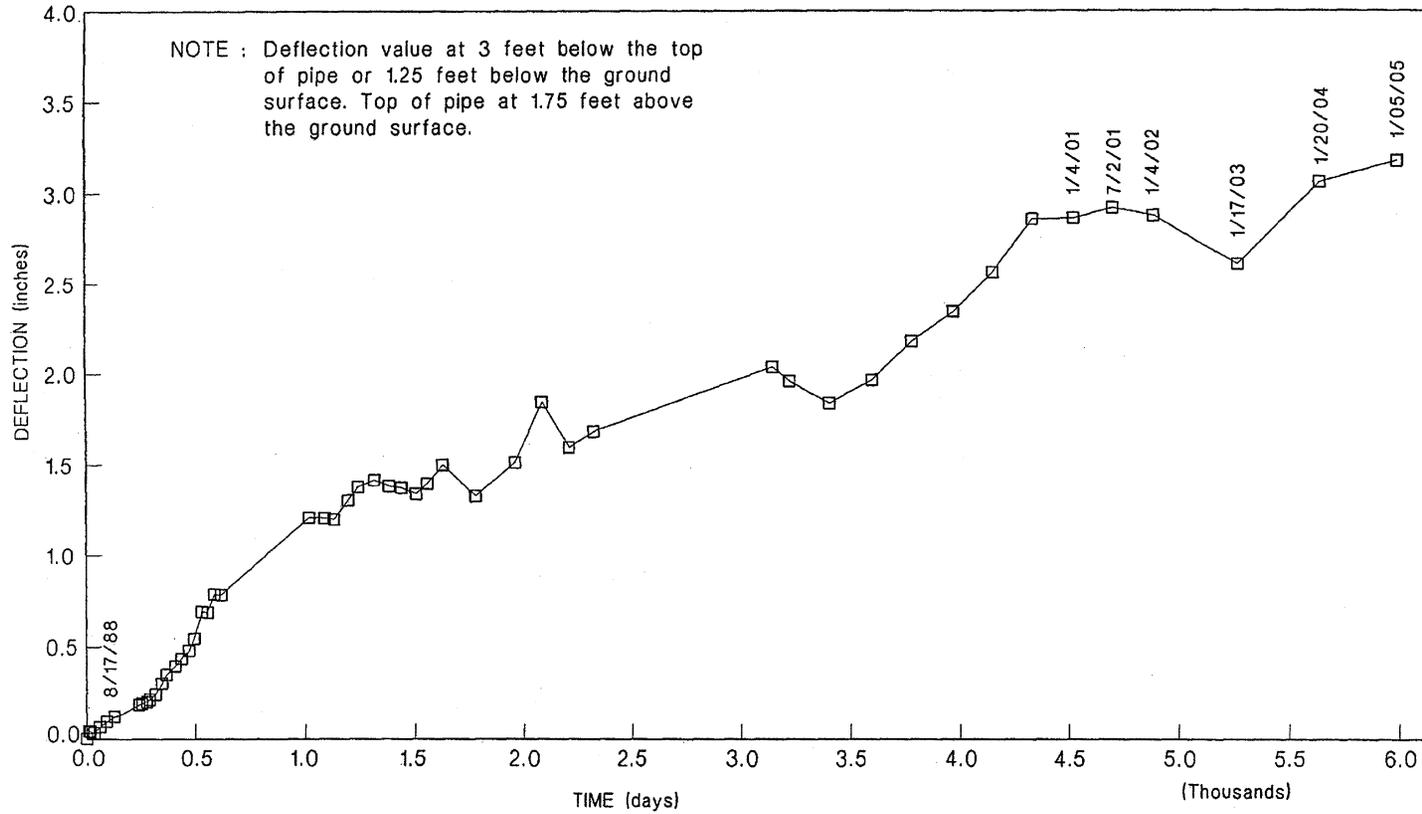
INCLINOMETER I-3

WCC estimates that the depth to the failure surface is as much as 40 feet in some places, but is generally shallower than that. Inclinometer I-3 (Figure 3) indicates a depth of about 15 feet. It is estimated that the depth of sliding within the property at 510 Kuli'ou'ou Road ranges from 0 feet at the toe to perhaps as much as 20 feet near the middle of the lot.

DEFLECTION vs. TIME

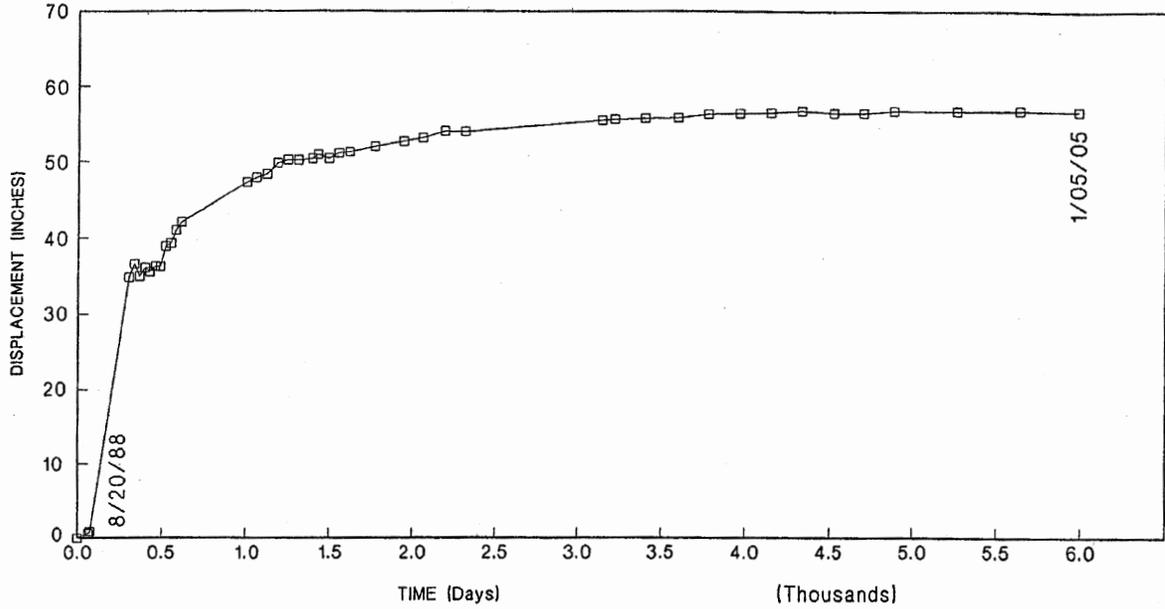
STATION 4 - POC MON 7+03.43

Good examples of creep are provided by the data in Figures 4 and 5. The early time portions of the curves show much higher rates of deformation than the later ones. Indeed, WCC report ground surface movements on the order of about 0.25 inches per month between April and November of 1989. Displacements accelerated to as much as 1.0 to 1.5 inches per month between December 1989 and April 1990 due to additional rainfall. These deformations presumably occurred during a period when the soil was quite wet. They also probably reflect a certain amount of residual mobilization during a period when the landslide was transitioning to a new state of equilibrium.

More indicative of pure creep are the displacements seen in Figures 4 and 5 after the first one to two years of measurements. As already pointed out, since 2001 the rate of deformation in all the instruments is less than about 0.4 inches per year. It is our assessment that this value can be taken as the average rate of downslope creep movement for areas within the boundary of the landslide under typical conditions of low to average long-term precipitation. During extended and significant rainfall periods, probably on the order of many days to weeks, creep rates may rise somewhat above this value for short periods of time.

MONUMENT DISPLACEMENT vs. TIME

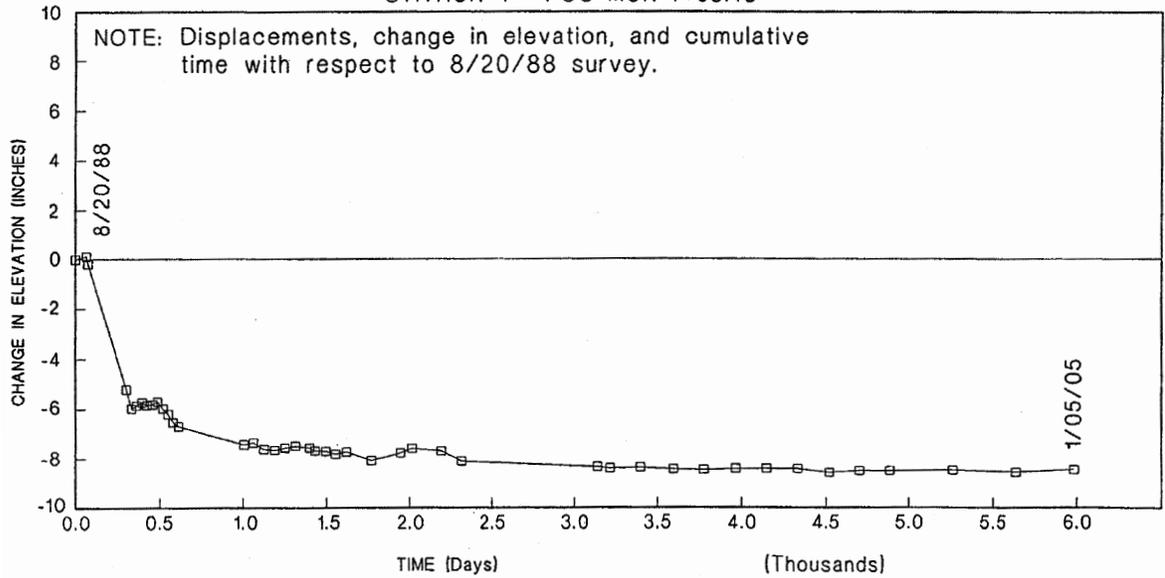
STATION 4 - POC MON 7+03.43

ELEVATION CHANGE vs. TIME

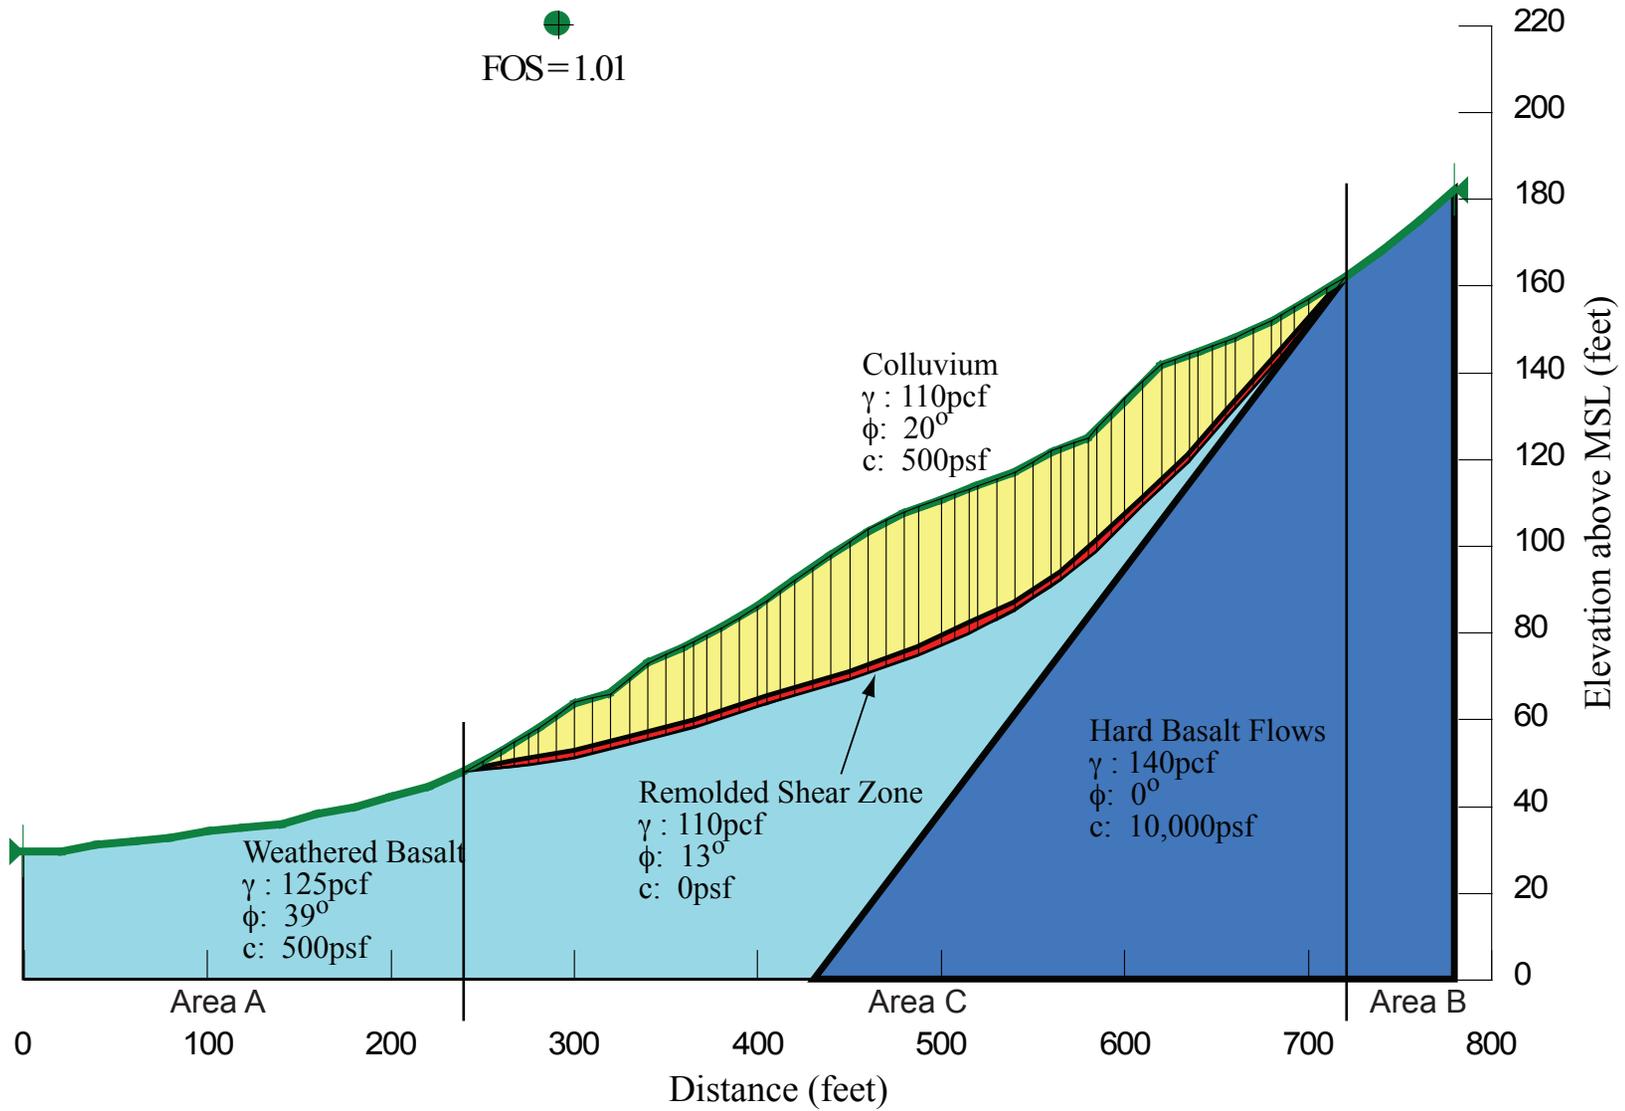
Cross Section B-B

There have always been extended periods of time when rainfall in the area has been no more than average, and often less than that. Piezometer data suggests that during much of this time there may not have been an effective groundwater table across the slope that would lower the safety factor to any significant extent. We believe that this is more or less the current state as of March 2011. The result of our slope stability analysis under these conditions yields a calculated factor of safety along line B-B of 1.01 (Figure 8). This indicates a stable slope at present time. It should be noted that a very large number of trial failure surfaces were analyzed. Invariably, the critical surface occurred within the confines of the remolded shear layer. This is because of the low residual strength of the soil in this

FOS = 1.01

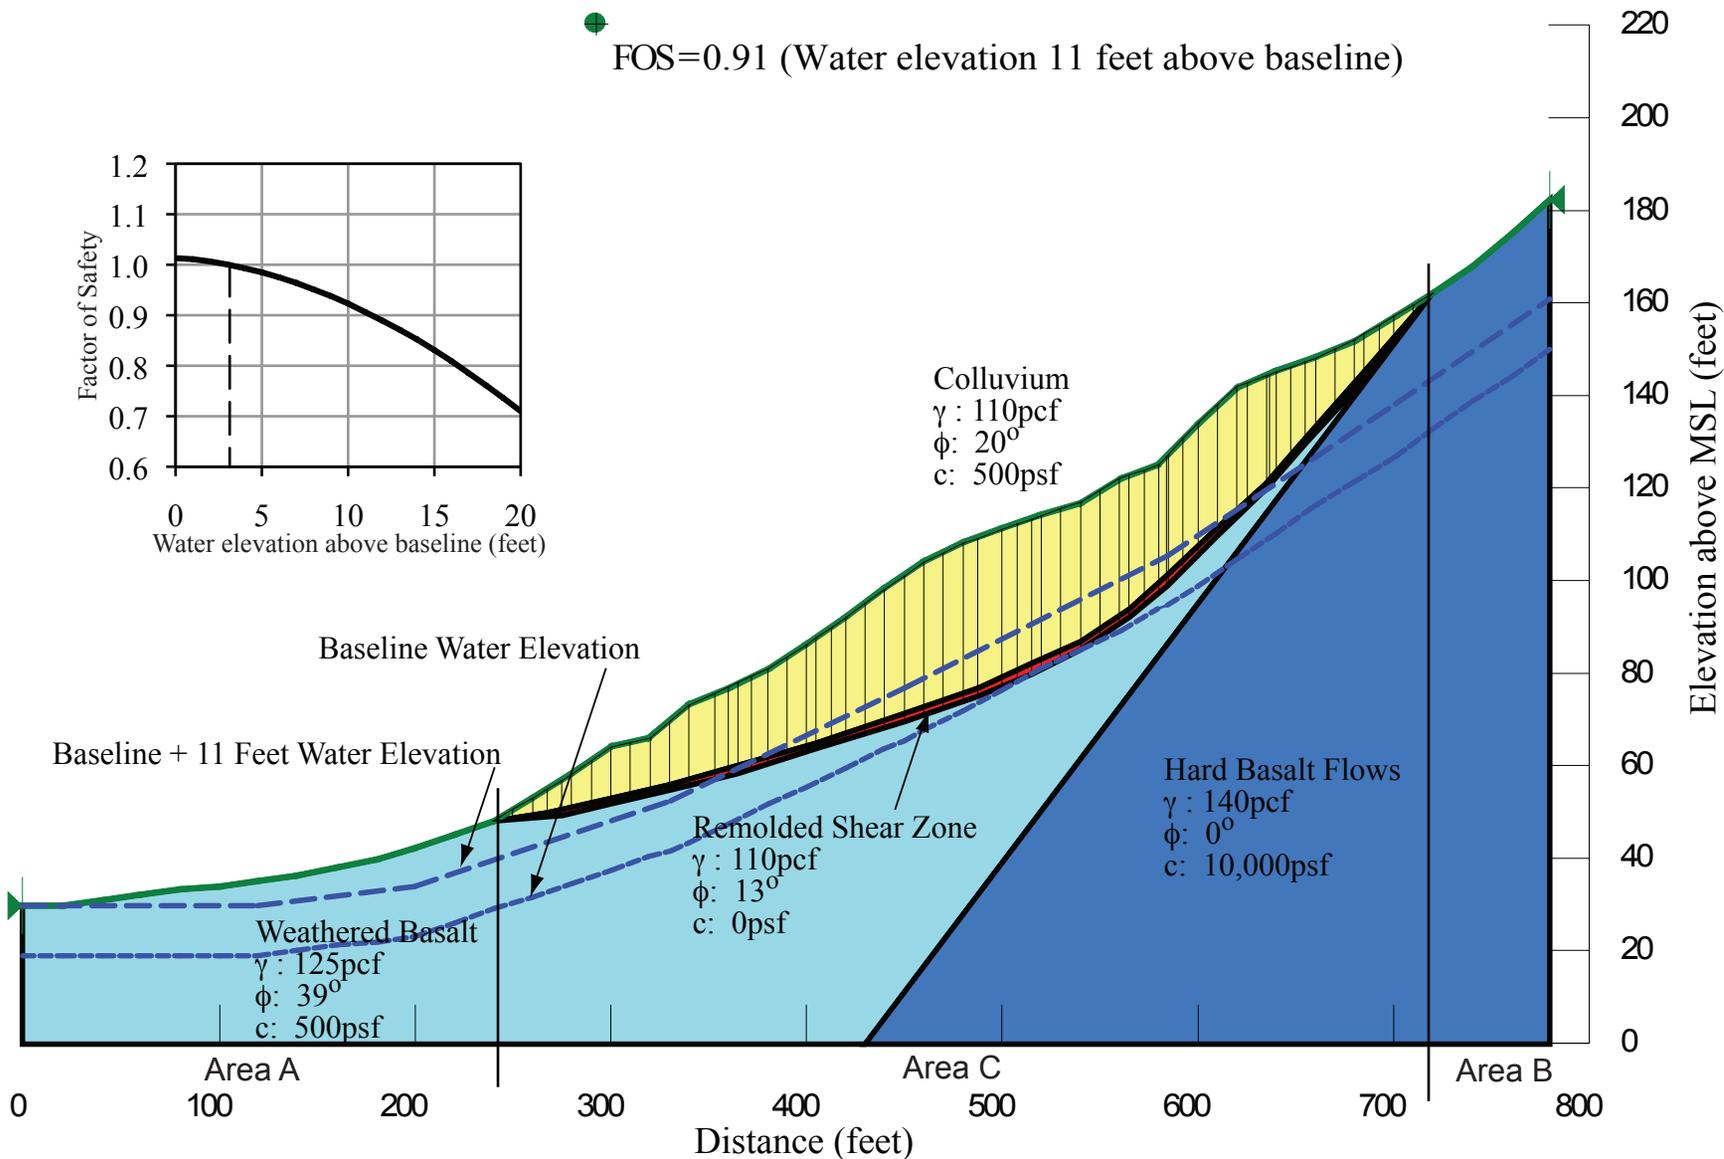
Cross Section B-B

To investigate the effect of a future rainfall event of sufficient duration and intensity to elevate the groundwater table above the level of the remolded sliding zone, we repeated the calculations with a perched groundwater table at various elevations. The results are also summarized in Figure 8. As long as a continuous water table remains below the remolded shear zone, the factor of safety does not change. The stability of the slope starts to decrease if the water table rises above the shear zone and into the overlying colluvium since effective stresses along the weaker sliding surface decrease, and this in turn reduces the shear strength. The slope becomes increasingly less stable as the location of the water table rises closer to the surface. The factor of safety crosses the 1.0 threshold when the water table is about 3 feet above what is shown as the 'baseline' water table in Figure 8. We believe that such an elevated transient water table developed during the New Year's Eve storm of 1987-1988, causing mobilization of the landslide. Such a condition has not been repeated at any time since.

FOS=0.91 (Water elevation 11 feet above baseline)

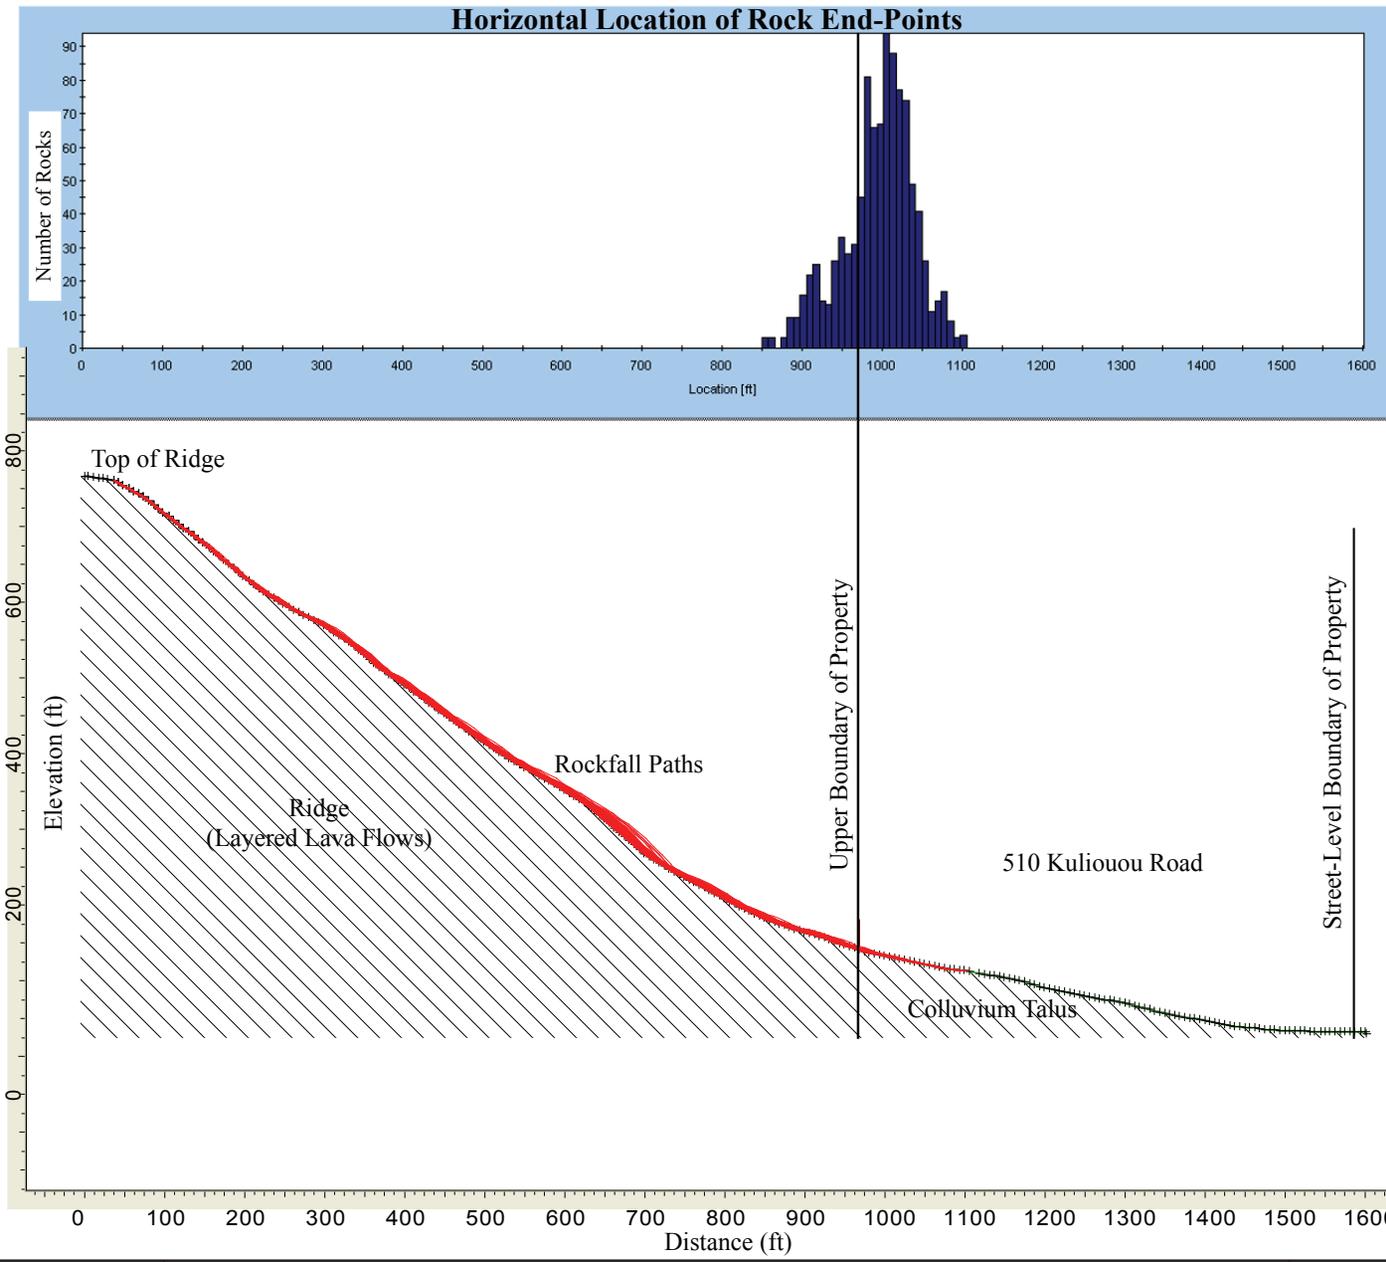
Critical rockfall trajectories are shown in Figure 10. As indicated, a fair number of boulders can be expected to cross the upper boundary of the property and come to rest near the top of the lot. None are seen to travel to the middle or lower portions. This agrees with our site reconnaissance, which identified large boulders in the upper portions of the property that had clearly descended from the ridge above at some point in the past.

A common means of protecting against destructive boulders is to install a flexible rockfall barrier or rock fence. Such a fence needs to be tall and strong enough to cut off the path of descending boulders. We believe that the most reasonable place to erect such a barrier is at or near the upper boundary of the lot. Computations indicate that maximum bounce height at that location is on the order of about 5 feet (Figures 11 and 12). Also, the maximum expected kinetic energy is on the order of 1,000,000 ft-lb (1,355 kJ).
